BAYLY POND DAM

NDI ID NO. PA-00343

PHASE I INSPECTION REPORT
NATIONAL DAM INSPECTION PROGRAM

JULY 1981

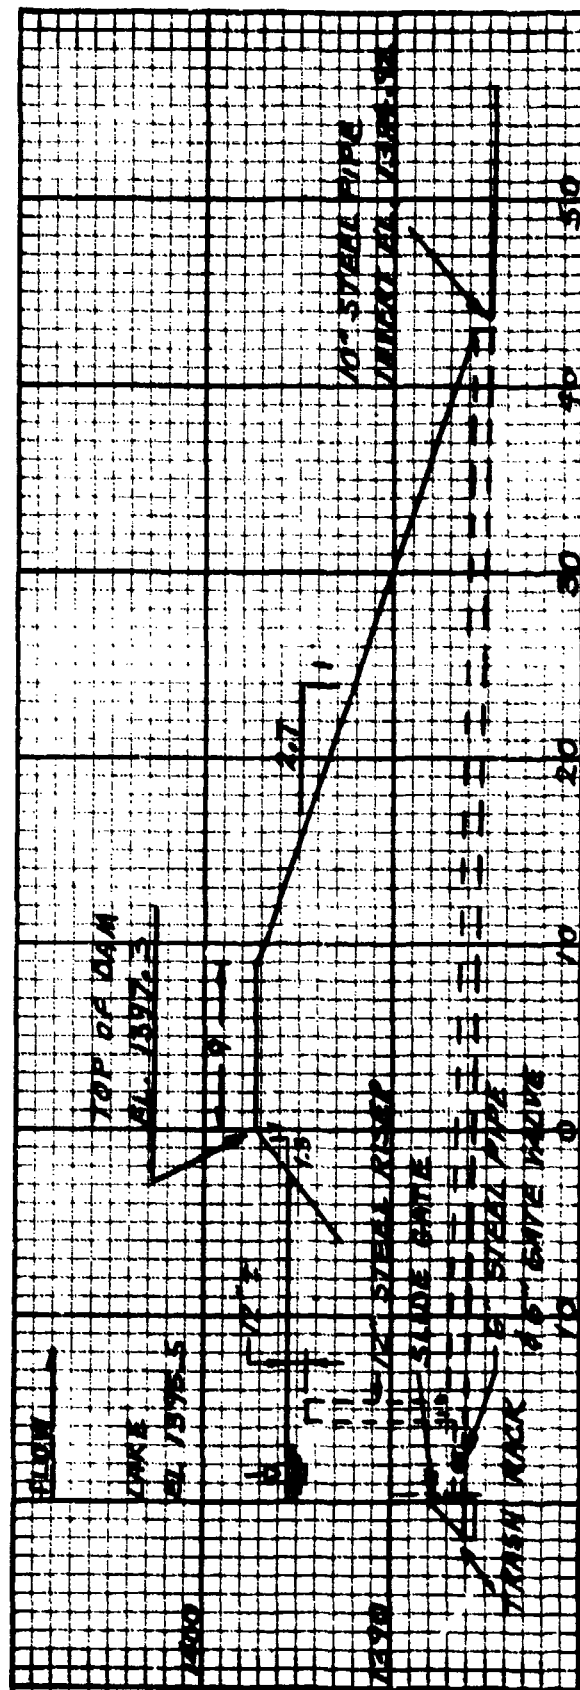
OUTLET WORKS

(2) Outlet Works: The outlet end of the 10-inch diameter steel pipe appears to be in good condition. A sketch based on the following description is presented in Exhibit A-5. The outlet works was described by the owner as having a small concrete intake box connected to a 10-inch diameter outlet pipe by a short length of 6-inch diameter pipe that has a 6-inch gate valve. A 12-inch steel riser pipe is also connected to the 10-inch outlet. The top of the riser, described as being approximately 12 inches below the emergency spillway crest, was not visible on the day of the inspection. The outlet pipe discharge observed during the inspection was a fraction of the flow expected for the outlet works with a 1-foot head over the crest of the riser pipe (see Exhibit A-5). Consequently, the outlet works is considered to be partially blocked and the elevation of the emergency spillway crest is the normal pool elevation.

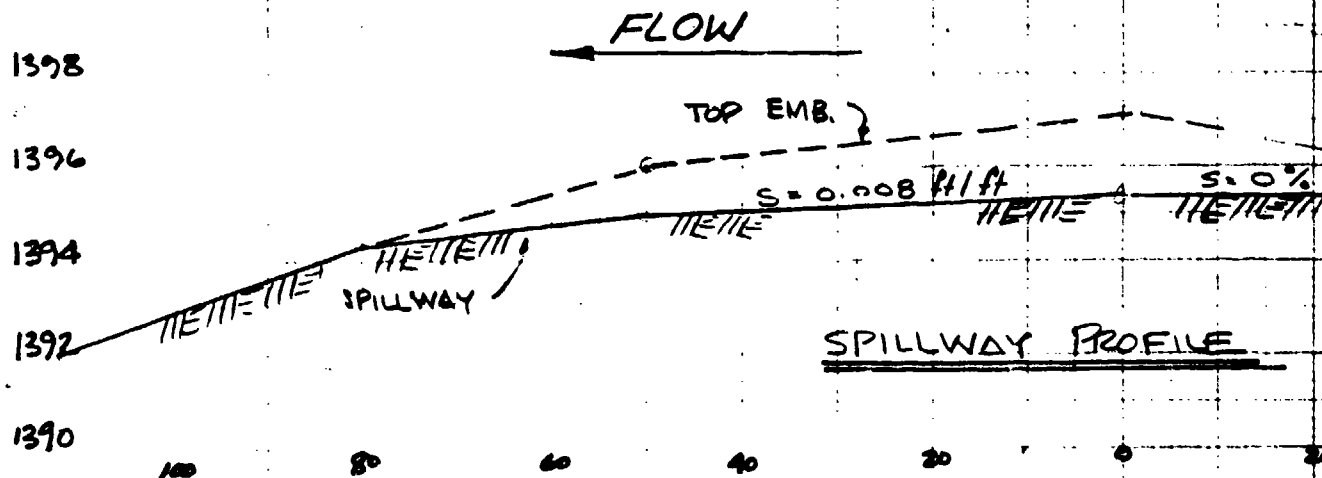
SPILLWAY PROFILE

Because the present capacity of the spillway will not pass the selected SDF without overtopping the dike and the dam, the spillway is rated as inadequate.
